Re-Design of Nickel Ore Hopper

Project Scope

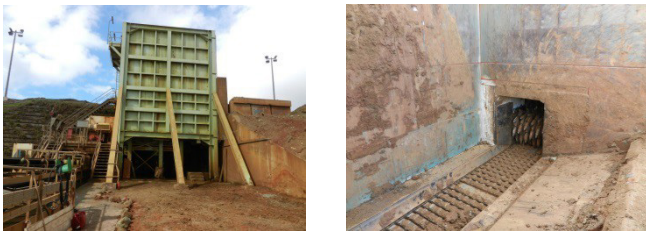
A flat bottomed road receival hopper, acting as the entry point to a nickel ore handling facility, was observed to arch and rathole. This resulted in sporadic flow (surges), blockage and ultimately costly downtime for the client. The existing hopper and feeder/breaker arrangement (hopper floor) is shown in Figure 1.

Figure 1: Existing Hopper, Feeder and Breaker

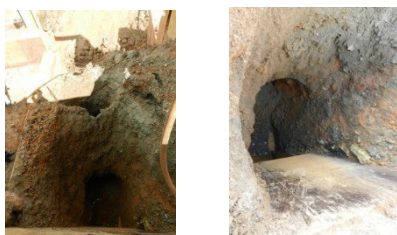
Figure 2: Arching and Ratholing on Site

The ratholing, arching and blockage as observed on site is shown in Figure 2. Due to client request, conceptual re-design was restricted to not modifying existing geometry which included the feeder/breaker.
