Improvement of a Discharge System for Aluminium Hydrate

Project Scope

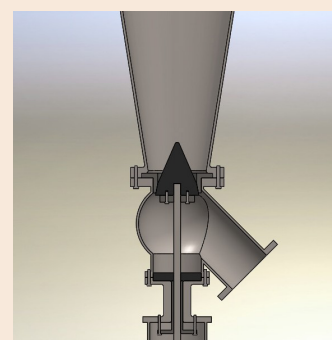
Figure 1: Existing metering valve

Equipment: Existing metering valve used to discharge alumina into a pneumatic conveying system at a rate of 1 to 20 t/h. The valve operates via a conical plug moving up or down, thus changing the annular opening size and controlling the material discharge.

The client always assumed that the discharge issues do not result from the metering valve operation but from material arching in the feed hopper. Therefore, air jets had been put in place in this hopper to break the material bridges. The investigation revealed that the annular opening of the metering valve was too small for the aluminium hydrate, resulting in material arching across the opening. The circular orifice was 70 mm when fully opened while flow property testing showed that the material's critical arching dimension is 120 mm.

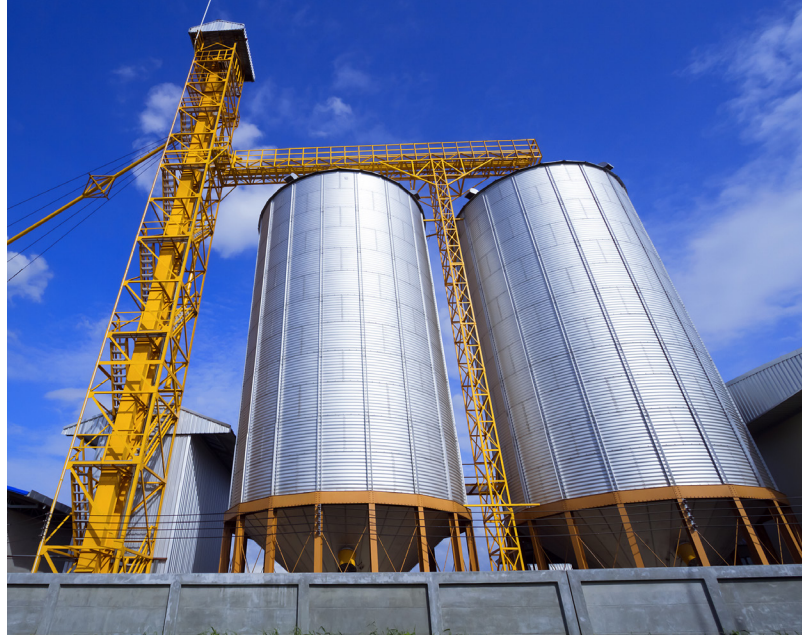
Replacement of the discharge system was the only solution. Using a screw conveyor was not recommended due to the great size of the screw required to avoid material arching and the resulting very low screw speed to achieve the desired low range of throughput. A Fuller-Kinyon™ Pump was found to not have any benefit for this application while having high risk of blockage, high maintenance issues and high power consumption. Using a rotary valve was found to be the most suitable solution to replace the current system, although wear must be considered.
